REPAIRS

# BOOM HINGE BEARING REPLACEMENT – ZPMC

ZPMC STS CRANE, FRANCE

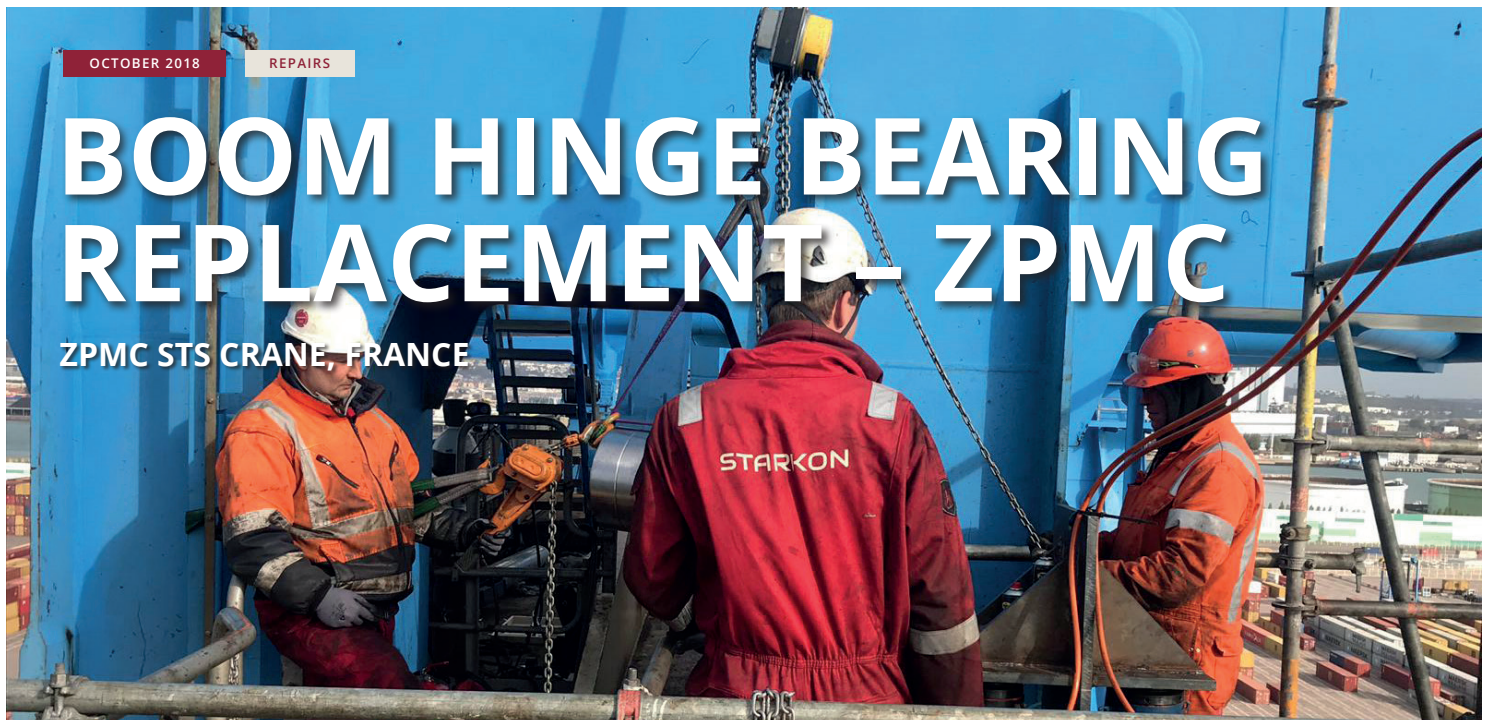
Replacing the bearings and shaft of this type of crane boom hinge is even a bigger challenge than on most European brand cranes. There are two spherical bearings installed which cannot be removed in a normal way.

To calculate and design the jacking system for the boom in all directions taking into account the possibility of heavy winds to ensure safety. To remove the shaft with help from STARKON's Thermal Lance Service and to replace the bearing and shaft of the boom hinge.

The complete shaft and bearings are replaced, and the boom operates as it should.
