REPAIRS

# THERMAL LANCE CUTTING SERVICE

## REMOVING SHAFTS WITH USE OF A THERMAL LANCE

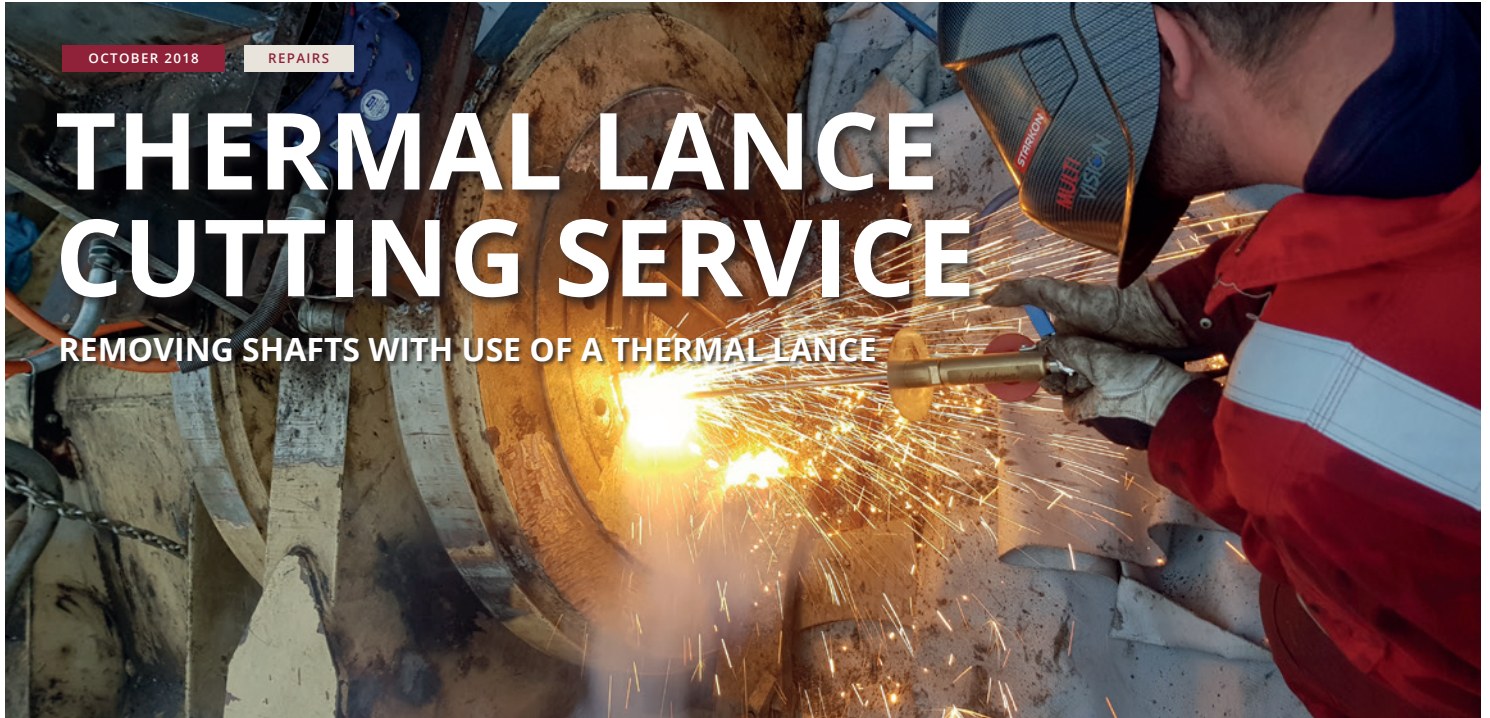
Removing a shaft which is stuck in the bore without damaging the original bore tolerance.

When all the regular methods to remove the stuck shaft had failed, STARKON Industrial Services provided the solution. The company melted the shaft using a thermic lance with an operating temperature of 2500 °C in combination with trained, skilled operators.

The shaft is easy to remove once the thermic lance cuts it. The original bore dimension will still be intact and a new shaft and its components can be installed.
