THE CHALLENGE

After 15 years of operations, the trolley drive train was worn out, and it was time for a complete replacement. The overhaul had to be done in a tight timeframe to minimize the crane's downtime.

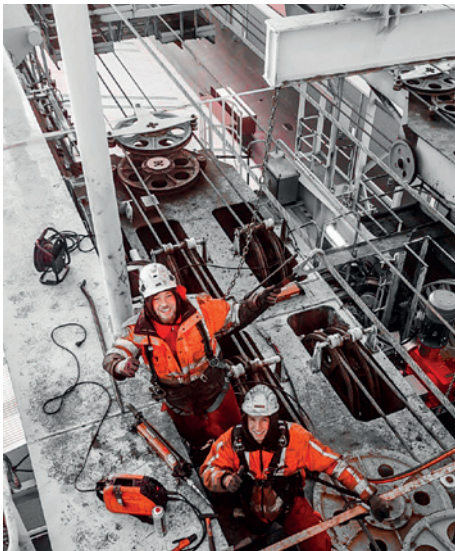
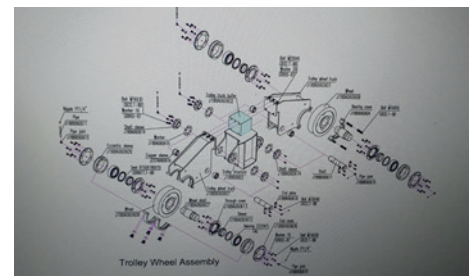
The overhaul of the complete drive train of the ship-to-shore crane resulted in the smooth function of the trolley operations. The crane is now ready for another 15 years of container movements.

- a project safety plan including risk analyses;
- a project schedule including a daily progress update;
- the whole body vibration measurement;
- replacement of all trolley drive train parts;
- trolley wheel alignment after the replacement;
- wheel replacement;
- all bearings and shaft replacements; and
- truck buffer replacement and height adjustment.
