## THE CHALLENGE

After 15 years of operations, the trolley drive train was worn out, and it was time for a complete replacement. The overhaul had to be done in a tight timeframe to minimize the crane's downtime.

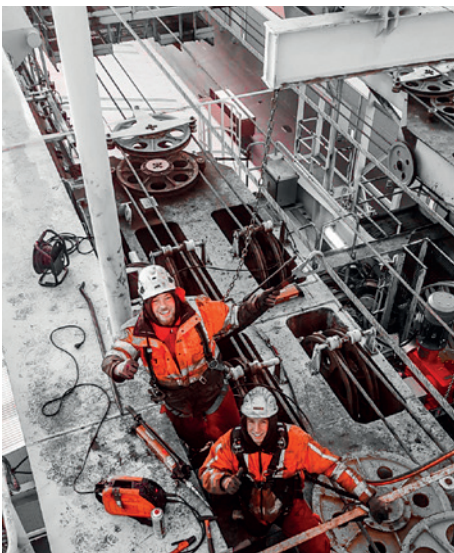
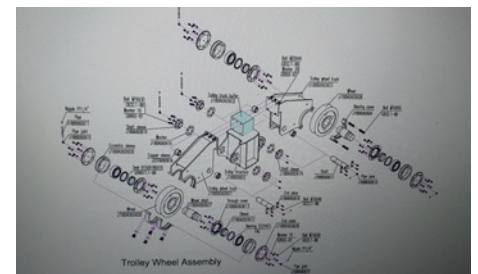
Even with some setbacks like adverse weather conditions, STARKON succeeded to complete the project within the tight schedule. The overhaul of the complete drive train of the ship-to-shore crane resulted in the smooth function of the trolley operations. The crane is now ready for another 15 years of container movements.

- a project safety plan including risk analyses;
- a project schedule including a daily progress update;
- the whole body vibration measurement;
- replacement of all trolley drive train parts;
- trolley wheel alignment after the replacement;
- wheel replacement;
- all bearings and shaft replacements; and
- truck buffer replacement and height adjustment.
