REPAIRS

SMOOTH RAIL TRANSIT

STS CONTAINER CRANE SHORT RAIL REPLACEMENT & WHEEL ALIGNMENT

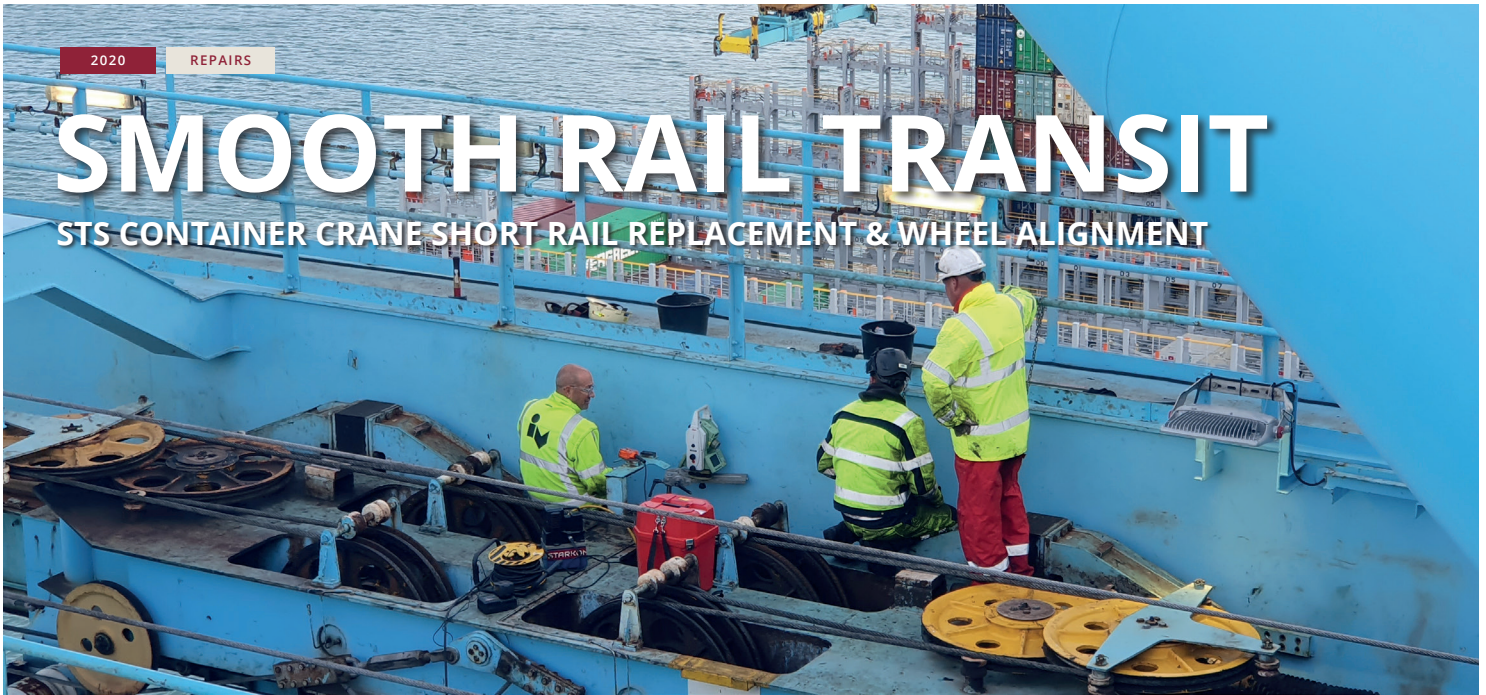
STARKON's STS Crane rail team performed an inspection on an STS crane after reports were received that the trolley was vibrating. During the inspection, several items were identified as to being the cause of the vibration.

- We supplied the parts required. All were made in-house such as the trolley rail, transit and underlayment material, rail clips, and the trolley's bushings.
- We replaced the shortrails of the transit as well as the worn-out parts of the trolley rail.
- We adjusted the complete rail length rail span.
- We replaced several rail clips and the underlayment material.
- We aligned the trolley wheels and guide rollers.

STARKON again (over 30 replacements have already been performed by STARKON) achieved a perfect rail transit and a smooth trolley operation. This increases the comfort of the operator, extends the life of the components, and increases productivity.
