REPAIRS

RMG GANTRY WHEELS

ZPMC RMG CRANE

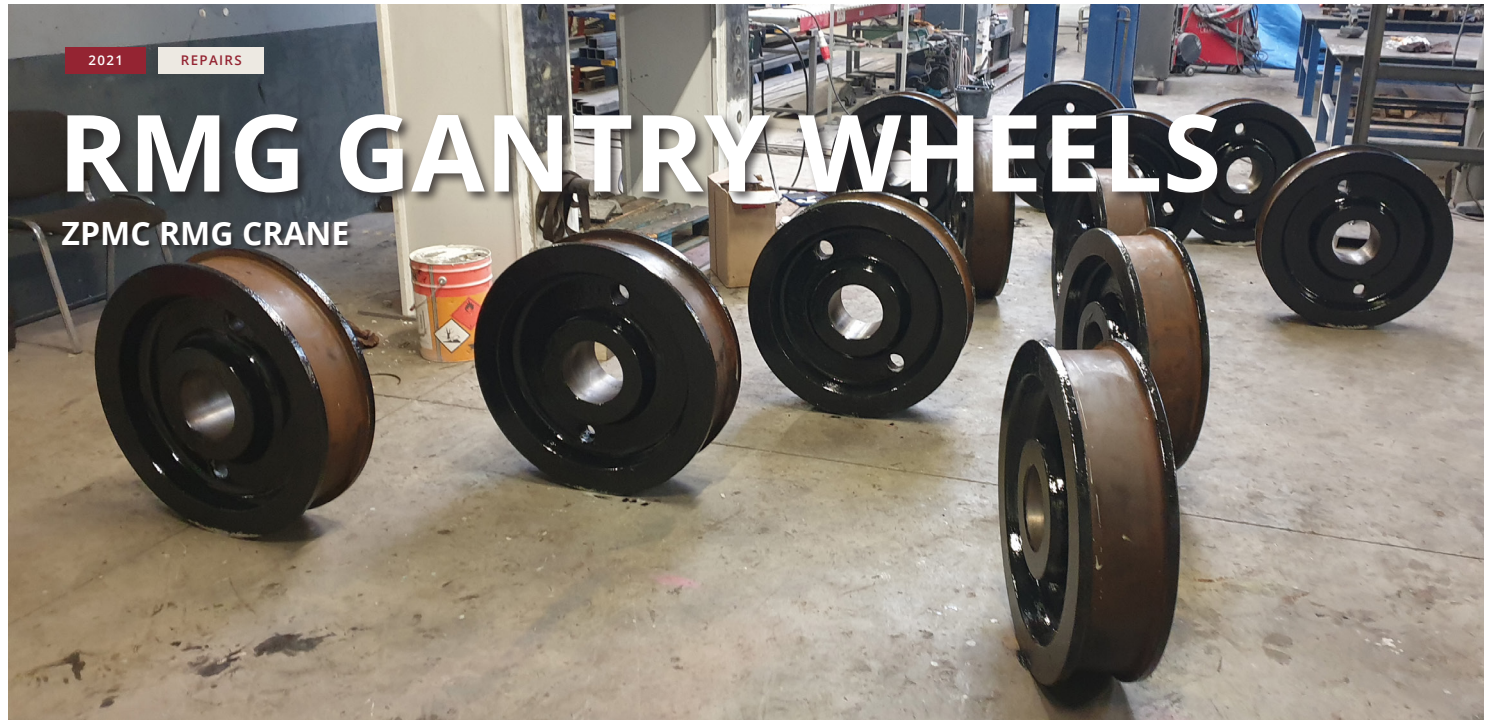
STARKON's client requested the removal and installation of several gantry wheel shafts for modification purposes. After more than 13 years of service, removing these shafts from the wheels requires proper tools and craftsmanship to avoid any damage to the parts that are to be re-used.

In STARKON's workshop, the proper tools and equipment are present to perform these kinds of jobs. 400 Tons of available pressing capacity combined with cord induction equipment to properly heat the wheels were used, and all shafts were removed without damaging any of the bores.

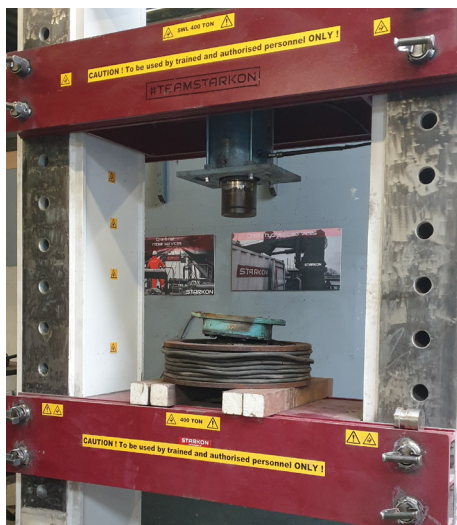
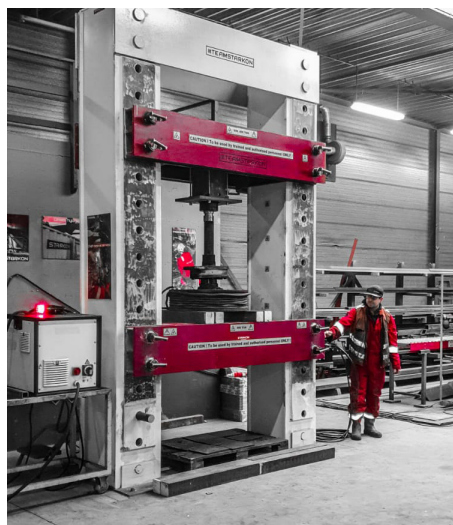
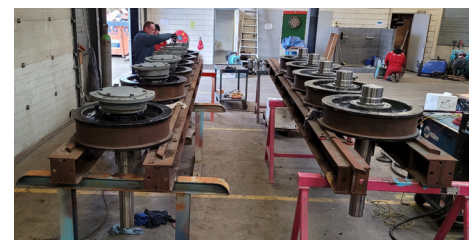
After removing the old shafts, the wheels were prepared to install new shafts followed by the remaining components. After some new conservation and proper greasing, all is ready to be re-installed under the crane.
