STS CRANE SHORT RAIL REPLACEMENT

GMP LE HAVRE

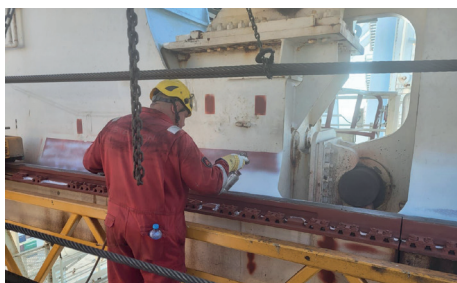
A common issue on STS cranes is the lifetime and replacement services of the trolley short rails. The short rail created a heavy vibration causing several unwanted issues like a short lifetime, cracks in the rail, unpleasant operating for the operators, and shorter lifetime off trolley components.

After STARKON's crane rail team was selected to replace an A75 short rail on the client's crane, it was now time to perform two more replacements on two other cranes but now with A100 short rails.

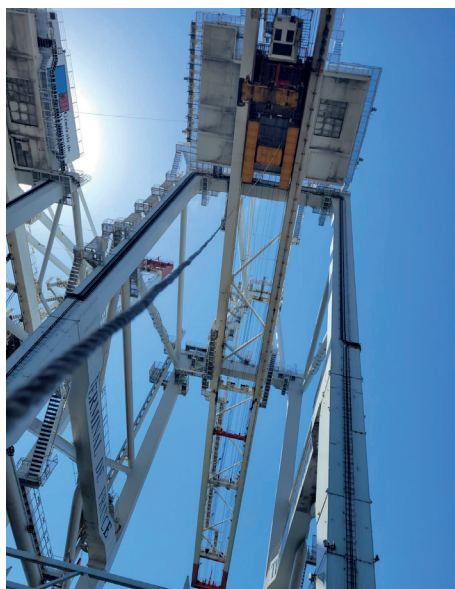
As STARKON has wide experience in the field of short rail replacement and production, STARKON was selected to design, produce, and replace the eight pieces of short rail for two cranes by the client.

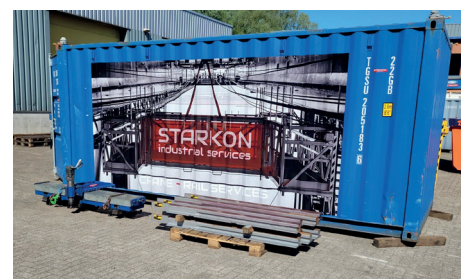
Managing the short lead time of the parts (3 weeks) and the short lead time for the replacement on the cranes (10 days each) STARKON replaced the short rails and repaired the rail bed itself, resulting in a smooth rail transit off the trolley.
