2021

MAINTENANCE

BULK-HANDLING CRANE, GANTRY OVERHAUL

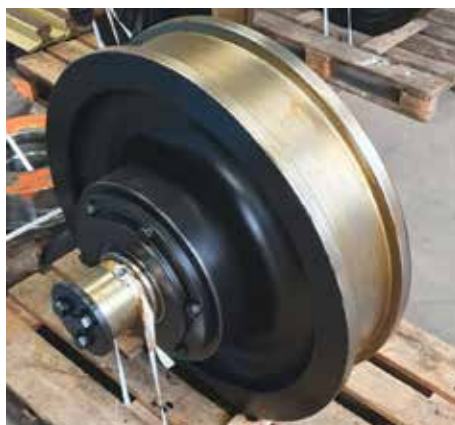
Through over a decade of experience in all kinds of industrial services, STARKON knows that removing these wheels requires proper tools and craftsmanship to avoid damage to the parts to be re-used. The challenge here was the crane's age, referring to the shafts mounted for a very long time, so most likely very stuck as well. And indeed, the shaft of the equalizer didn't come out with hydraulic pressing by 160T.

STARKON's motto/mentality is: "open to opportunities other than the standard solutions". As mentioned within "The challenge", the shaft did not come loose by the conventional method, which is hydraulic jacks.

aSTARKON did the job Without damaging the parts which needed to be re-used. This is a method done by specialists like STARKON.

STARKON's Team-effort, which brought together and properly aligned different disciplines, all of which are found in-house at STARKON, ensured the job was done before the agreed deadline. This was done despite the extra works (Thermal Lance Cutting) required. Besides the onsite works, our mechanics built new sets of Gantry Wheels in our Workshop in Stellendam.
