THE CHALLENGE

<https://starkon.nl/project/rmg-trolley-rail-replacement>

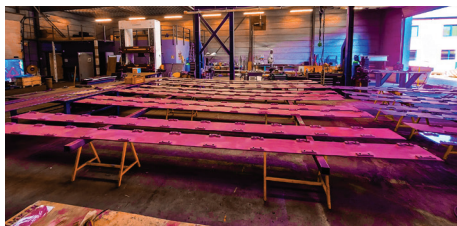
STARKON's crane service team was selected by its client due to previous research and a proposal submitted by IV-Consult and STARKON which was requested by the same client. The outcome of this new report was that the complete fully welded trolley rails needed to be replaced by a rail which is then mounted by rail clips from the RMG Crane. The complete soleplate of the rail will also be removed, and a new prefabricated sole plate, including welded rail clips will be installed by welding. Between the rail and crane girder, rubber underlayment material will be installed.

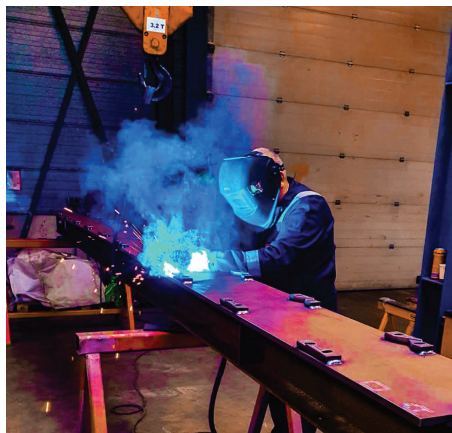
STARKON has wide experience in the field of (trolley) rail replacement and the facilities to prefabricate. The sole plates were prefabricated with welded bottom plates of the rail clips in STARKON's own workshop. After this, it was all transported together with the new rails, at an approx. length of 120m, other parts and a fully equipped Rail Service Container. The project then started onsite.
