REPAIRS

RETURNING CLIENTS

GANTRY WHEEL BOGIE REPLACEMENT

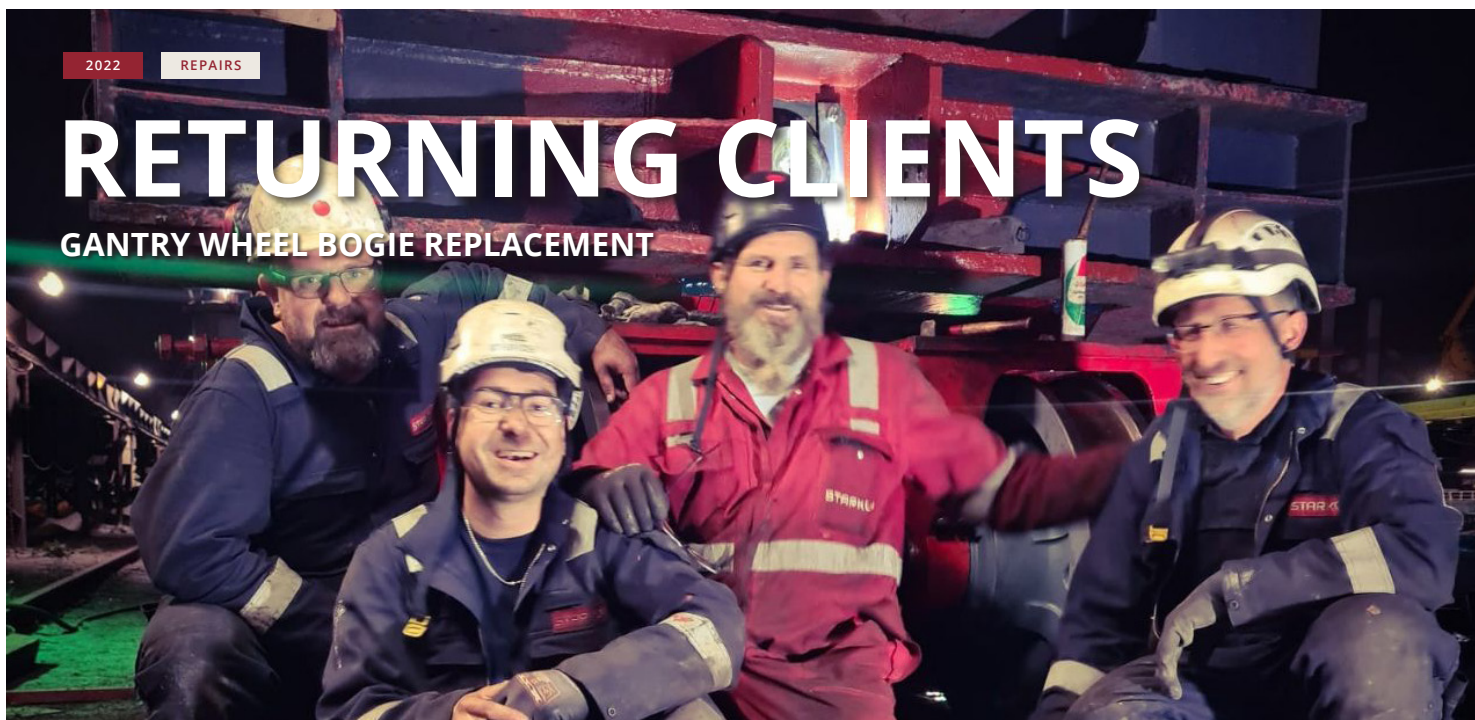
To safely and efficiently replace the wheelsets, we first needed to remove their weight. For this purpose, we developed a stooing mechanism and used hydraulic jacks to relieve the gantry set. Our team then proceeded to dismantle the axles, which proved to be challenging due to the age of the cranes and the harsh working environment. To overcome this, we utilized our in-house thermal lance team to cut out the stubborn axles. After the dismantling, all components were replaced, and those that could be reused underwent thorough inspection and revision. All of this had to be accomplished within a tight timeframe of 10 working days.

After completing the tasks within the designated time window, we conducted thorough testing of the crane in collaboration with the client. We also worked closely with our suppliers to provide the necessary components for the project. It was a fantastic undertaking, and we took great pride in the fact that the client continues to rely on STARKON's services. We value the trust they place in us and strive to maintain our high standards of quality and customer satisfaction with every project we undertake.
