INSPECTIONS

# TROLLEY WHEEL AND RAIL INSPECTIONS

## TROLLEY WHEEL ALIGNMENT

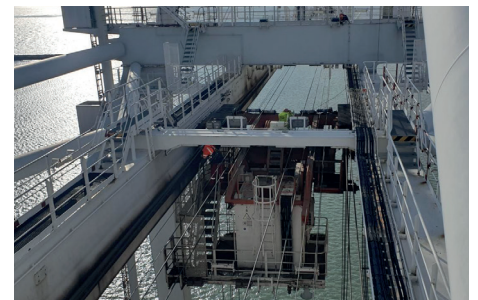
The inspection took place in 2 days, after the inspection the root cause was found and consisted of several small deviations in the inspected items. The result is a proper repair plan which results in a final solution. The repair plan can be used by the client to tender the work-scope to several subcontractors.

- Whole body vibration measurement.
- Trolley wheel alignment check.
- Wheel Bearing play inspection.
- Complete trolley rail including short rail inspection.
- Rail span inspection.
- Operator cabin buffer inspection
- Etc.
